Tornado Protection

Selecting Refuge Areas in
Buildings

FEMA P-431, Second Edition / October 2009

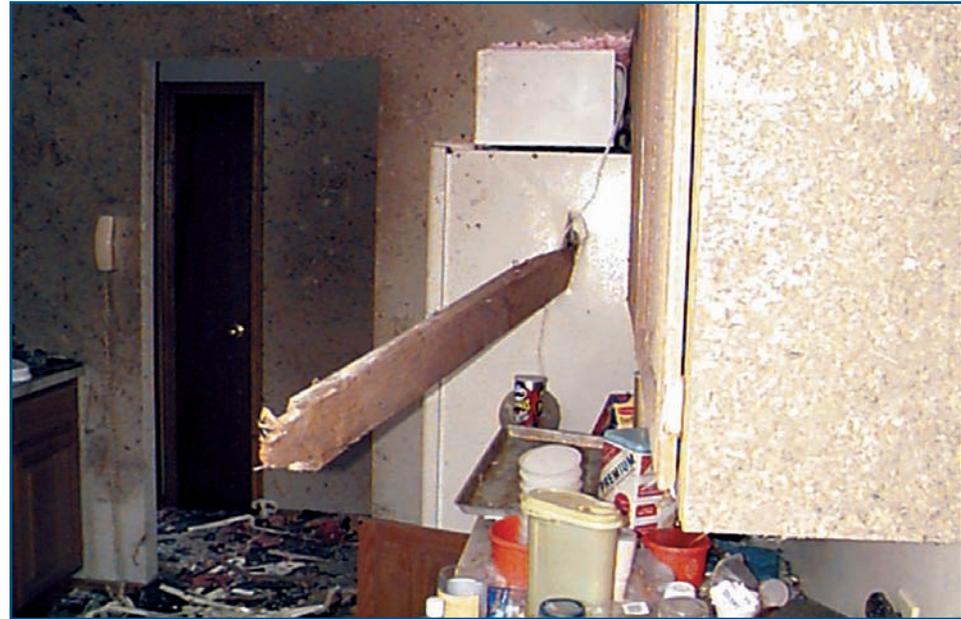
Figure 2-3
Example of severe damage from a windborne missile. This metal door was pushed inward by the impact of a heavy object.

The extreme winds in tornadoes pick up and carry debris from damaged buildings and objects located in the path of the winds (see Figures 2-2 and 2-3). Even heavy, massive objects such as cars, tractor trailers, and buses can be moved by extreme winds and cause collateral damage to buildings. Light objects become flying debris, or missiles, that can penetrate doors, walls, and roofs; heavier objects can roll and cause crushing-type damage.

Damage was also caused by the impact of windborne missiles. Figure 2-3, in Chapter 2, shows a steel door that appeared to have been opened by the impact of a heavy object. This door led into an area where the roof was missing. The opening created by this breached door may have allowed wind to enter the building and create internal pressure that increased the load on the building envelope. Figure 3-22 shows damage to a laminated glass window hit by a table.

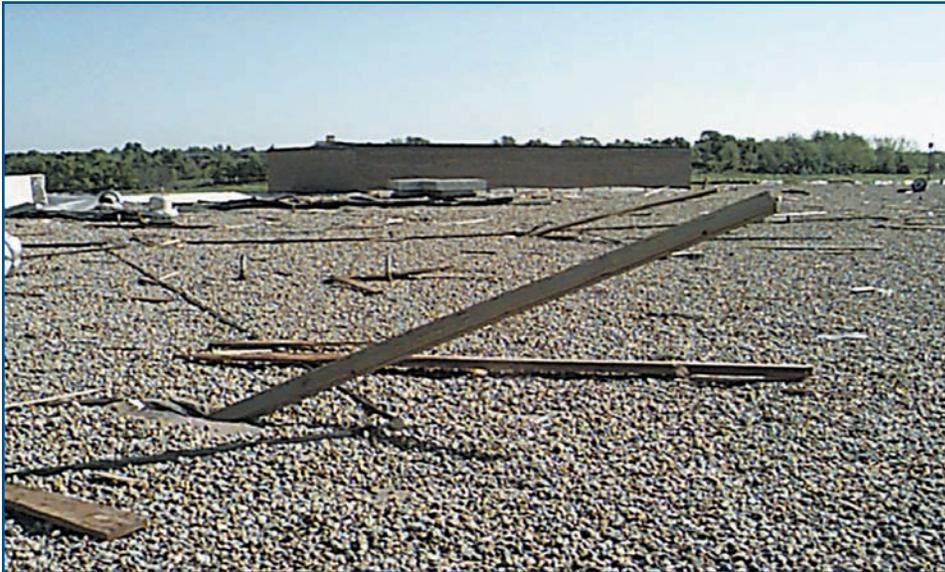
Example of damage from windborne missiles. Medium and small missiles penetrating through the roof of a high school. The missile protruding from the roof in the foreground is a double 2-inch by 6-inch wood board. The portion sticking out of the roof is 13 feet long. This missile penetrated a ballasted ethylene propylene diene monomer (EPDM) membrane, approximately 3 inches of polyisocyanurate roof insulation, and the steel roof deck. The missile lying on the roof just beyond it is a 2-inch by 10-inch, 16-foot-long wood board. The missile protruding from the roof in the background is a 2-inch by 6-inch, 16-foot-long wood board.

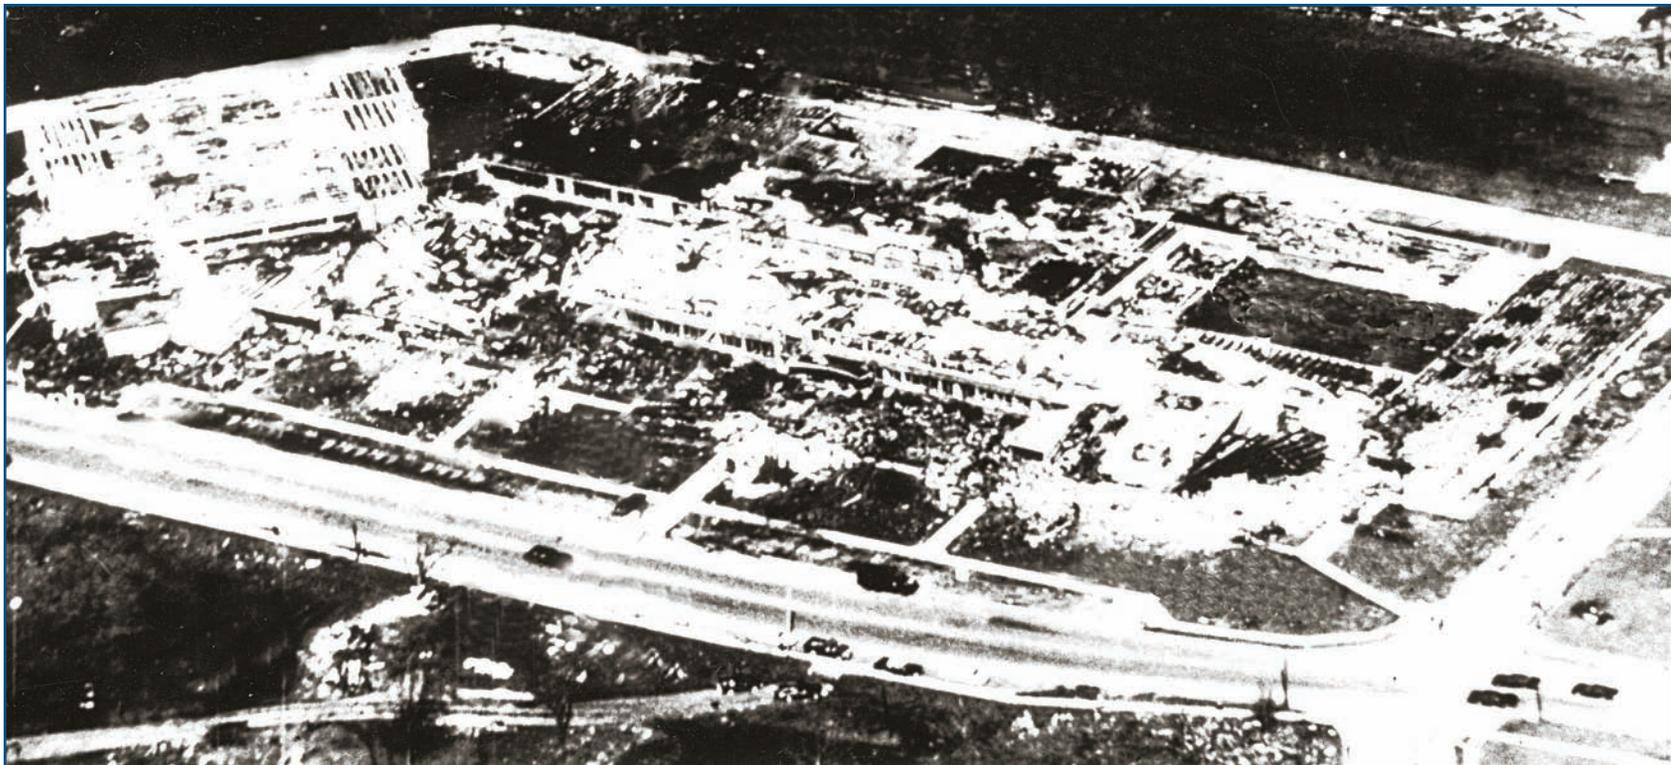
The enclosure walls failed on the west and south sides, allowing the winds to enter the building. The roofs collapsed over the three large spans—the auditorium, the boys' gym, and the girls' gym. The lightweight roof over the original two-story building was torn off by the extreme winds.

Figure 3-2 Xenia Senior High School, Xenia, Ohio.

All **windows** on the west and south sides were blown into the interior. The high single-story, **loadbearing masonry walls** of the **long-span** rooms failed, allowing the roofs to fall in. The unbaffled west entrances allowed the east-west corridors to become **wind tunnels**.

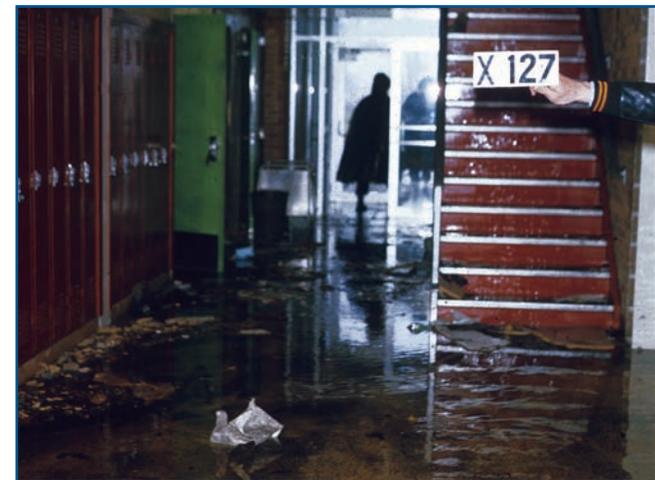
Figure 3-3
Surviving interior hallway. This is an example of the type of area that may provide refuge for building occupants during a tornado.

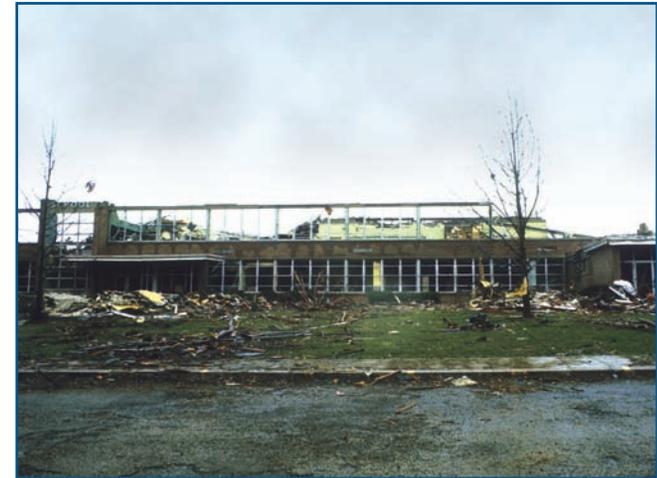
Figure 3-5
Loss of lightweight roof over the original two-story building.

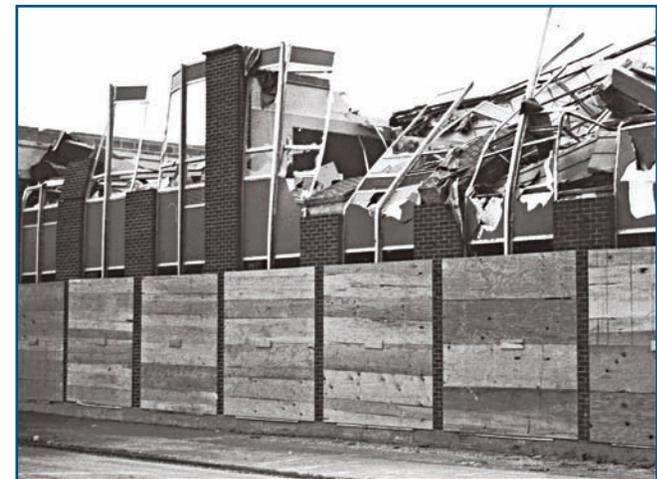
Figure 3-9
Collapsed second floor of St. Augustine Elementary School building.

The tornado winds lifted part of the roof and collapsed the second-floor piers in one wing of the school building (Figures 3-8, 3-9, and 3-10). The wind and windborne debris blew in most of the windows, and windborne debris was found in the classrooms (Figure 3-11). The exterior solid-core wood doors stayed in place and kept the debris out. Wired glass windows near the exterior doors remained intact. The interior doors to the classrooms remained in place although the hinges were damaged. The school was damaged to an extent where demolition was required.

The structural system of **unreinforced masonry piers** collapsed and almost one-third of the second-floor **lightweight roof structure** was lifted. Roof removal occurred over the classrooms as well as over the corridor. Most of the **skylights** in the corridors were removed by wind or broken by windborne debris. Almost all the **windows** on both floors were broken. Windborne debris and broken glass were found in the classrooms.

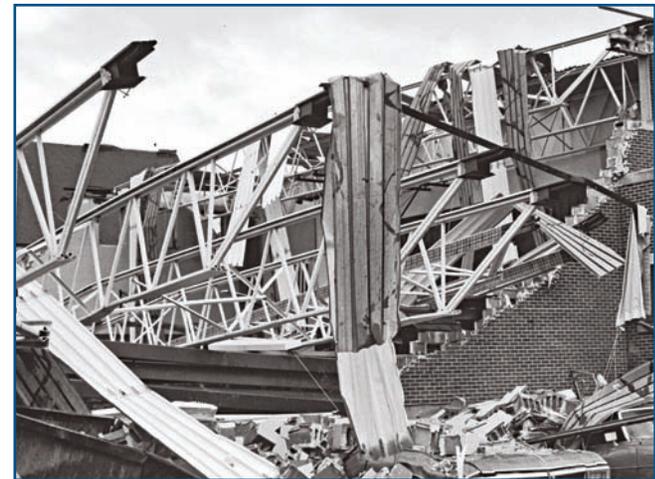
Figure 3-14
Collapsed St. Augustine Elementary School
Gymnasium building.

The unreinforced masonry walls combined with the lightweight roof structure in the building as well as the gymnasium building were vulnerable to collapse in windstorms. Gymnasium buildings are not considered suitable for occupant protection because they usually include tall walls and long-span roofs. Lightweight roof structures that are not adequately anchored can be lifted in windstorms. Except in violent (F4 and F5 in the Fujita scales or EF4 and EF5 in the Enhanced Fujita scales*) tornadoes, the lower floor (in two-story or higher buildings) generally provides good protection for occupants when there are two or more walls between the refuge area and the outside.

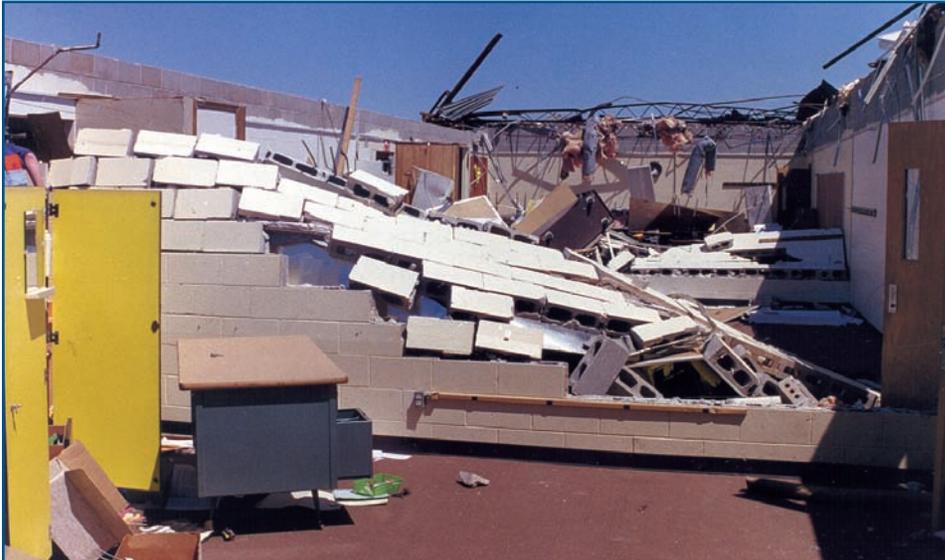
Unreinforced masonry walls failed when the roof system was lifted or removed by tornado winds (Figures 3-17, 3-18, and 3-19). Figures 3-17 and 3-19 show failed interior and exterior walls, respectively. Figure 3-18 shows the separation of the reinforced bond beam (indicated by circles) from the upper part of a corridor wall. The inclusion of clerestory windows in some corridor walls contributed to their failure under loads imposed by tornado winds (Figure 3-20).

Figure 3-17
Interior and exterior unreinforced masonry walls were damaged when reinforced bond beams failed.

The improvements discussed here are designed to prevent the types of damage to interior corridor walls and roofs shown previously in Figures 3-17, 3-18, 3-20, and 3-21. The reconstruction of the Kelly Elementary School is a good example of how refuge areas can be incorporated into new construction.

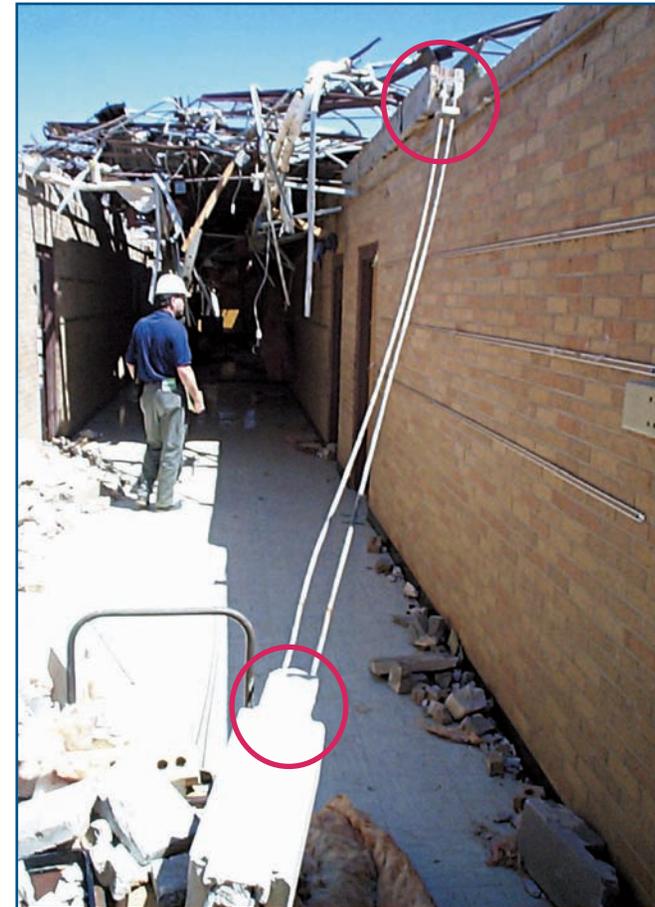
Figure 3-18
Corridor area. Separation of reinforced bond beam (indicated by circles) from supporting wall.

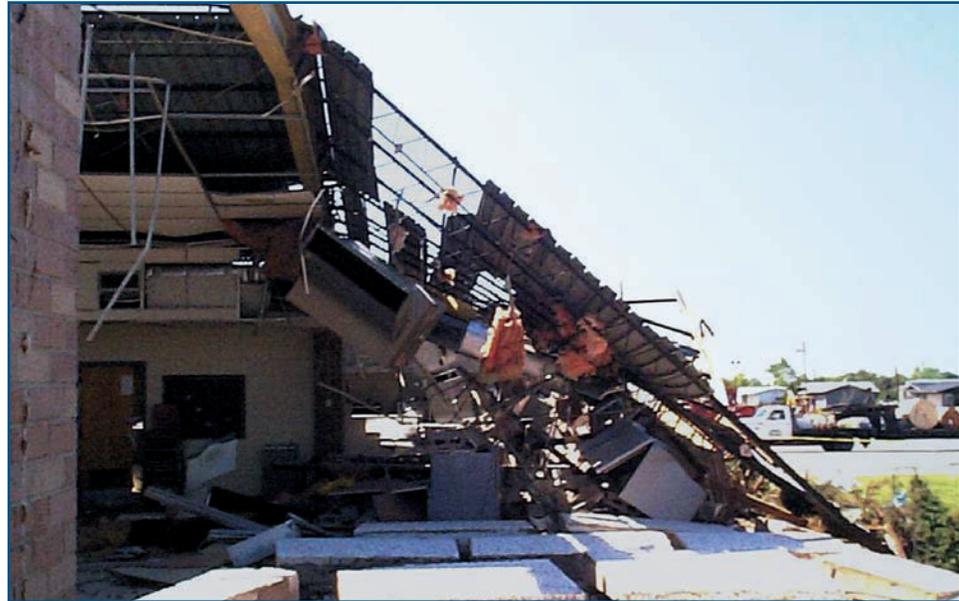
Figure 3-19
Collapsed roof structure and exterior wall.

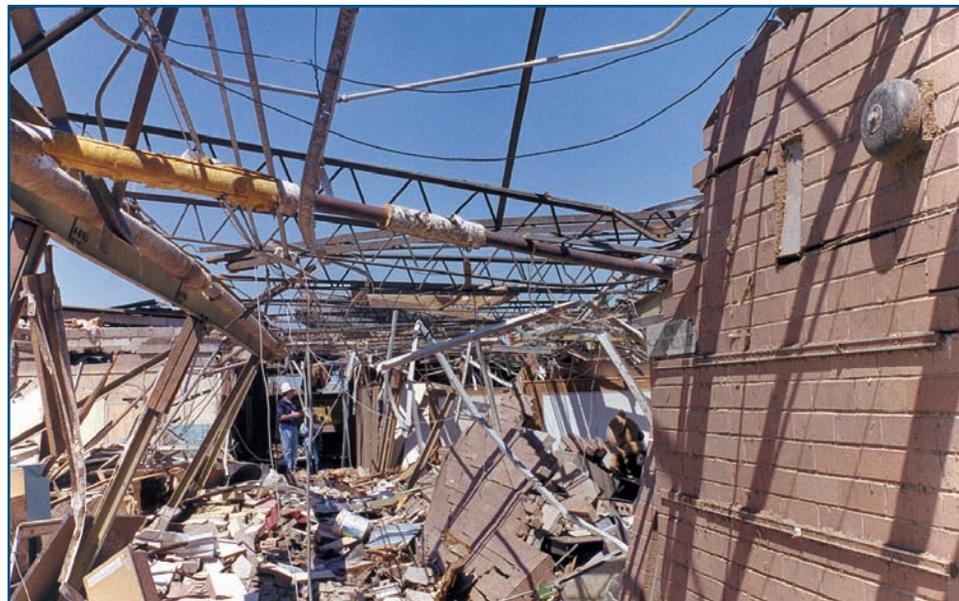
Figure 3-20
Failed interior corridor walls. These walls consisted of unreinforced brick masonry infill between steel-frame members. The brick masonry extended to a height of approximately 7 feet. Clerestory windows extended from the top of the masonry to the tops of the walls.

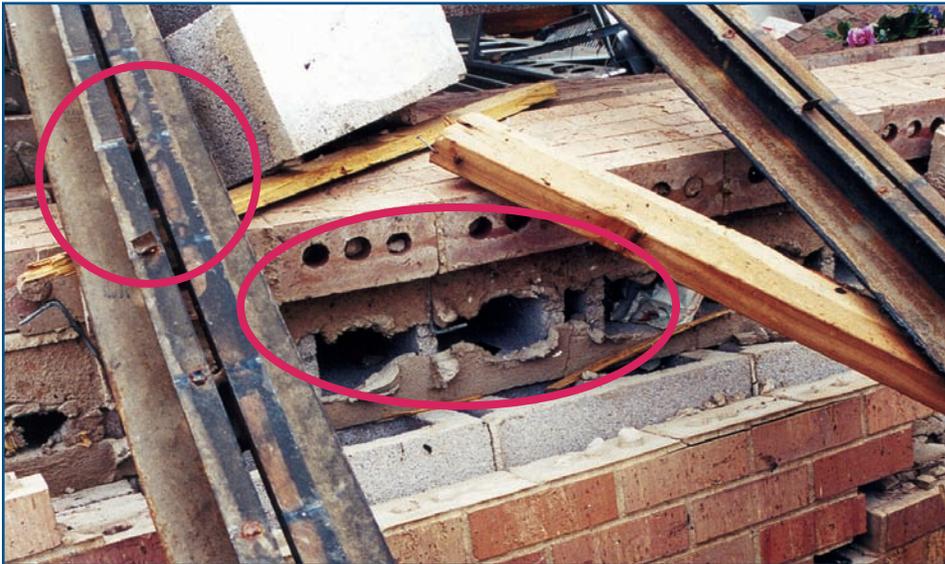
Inspection of the roof damage revealed that the roof decking failed at the points where it was welded to the tops of the steel trusses. Although the spacing of the welds appeared to be consistent with standard practice, the welds were not strong enough to resist the wind uplift forces (Figure 3-21).

Figure 3-21
Failed roof structure showing broken welds between metal roof deck and tops of joists (upper circle) and lack of vertical reinforcement (bottom circle).

Welds between the roof decking at the tops of the metal joists failed because they were **not strong enough to resist the uplift**.

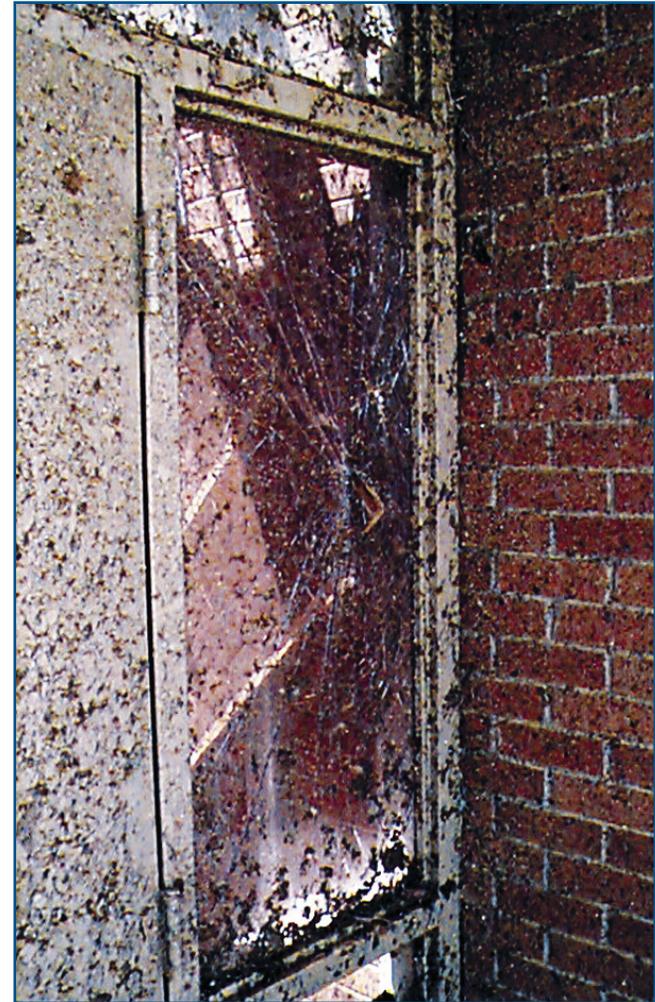
Figure 3-22
Impact performance of laminated glass. The corner of a table penetrated this laminated glass window, but the glass remained in its frame.

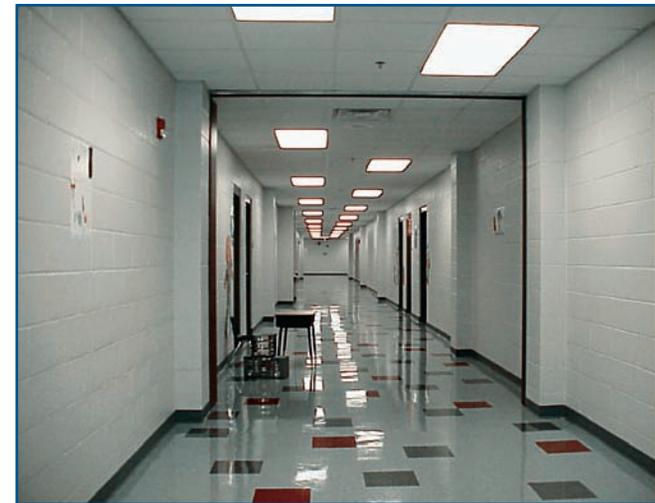
Figure 3-24
Corridor (designated safe area) in reconstructed Kelly Elementary School.

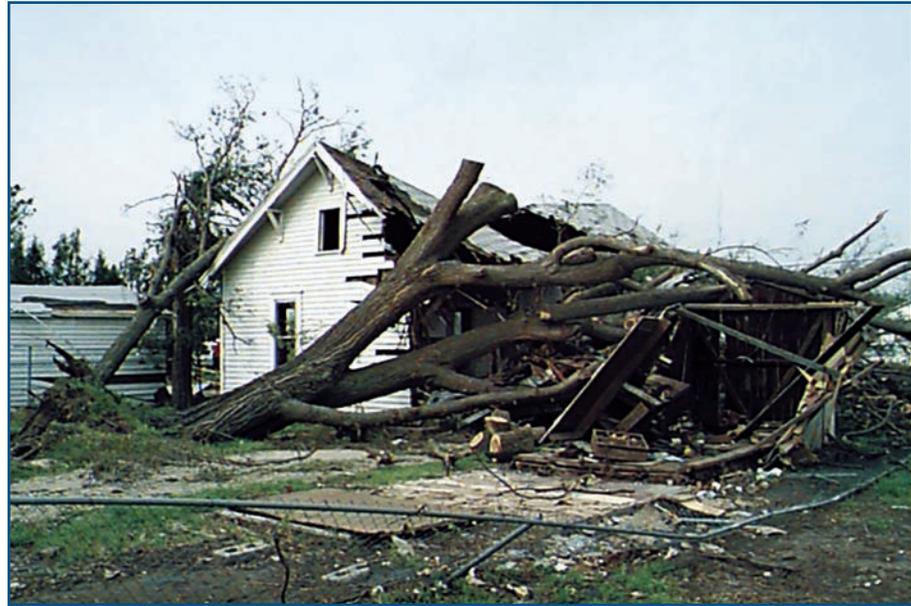
Figure 4-2
Two trees toppled by tornado winds damaged this house in Haysville, Kansas.

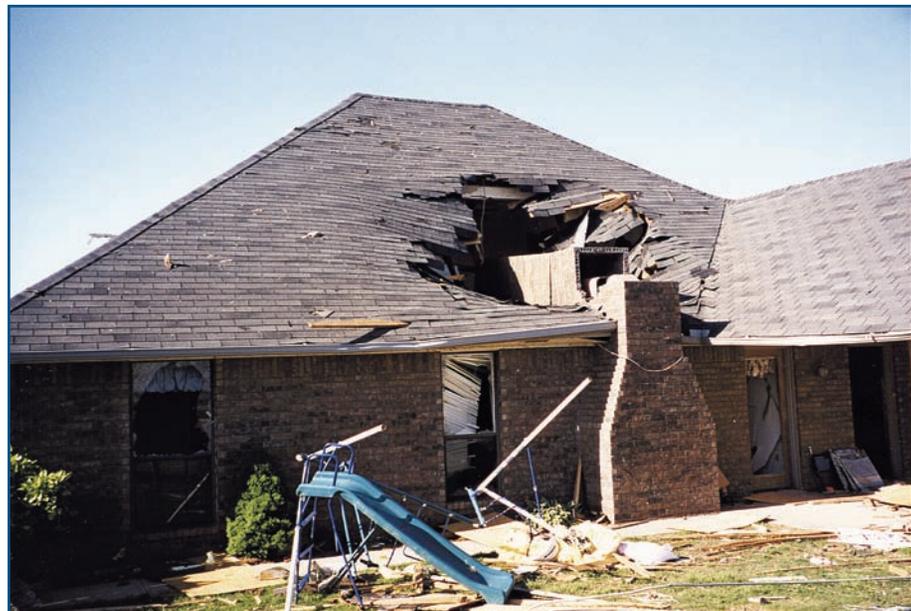
Figure 4-3
Failure of brick chimney under tornado winds damaged the room of this house in Moore, Oklahoma.

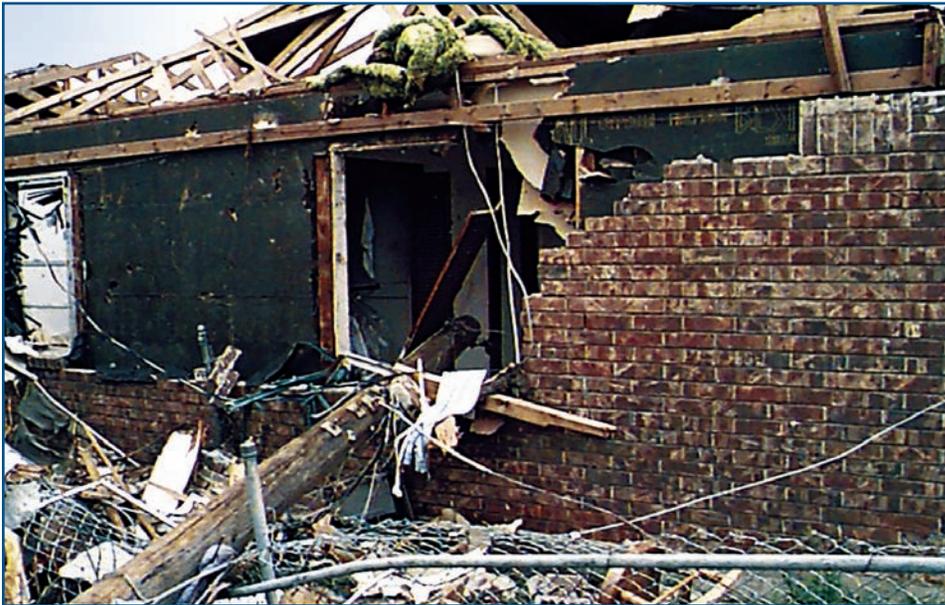
Figure 4-4
This power pole penetrated a window and extended several feet into the house after being blown 40 feet from its original location.

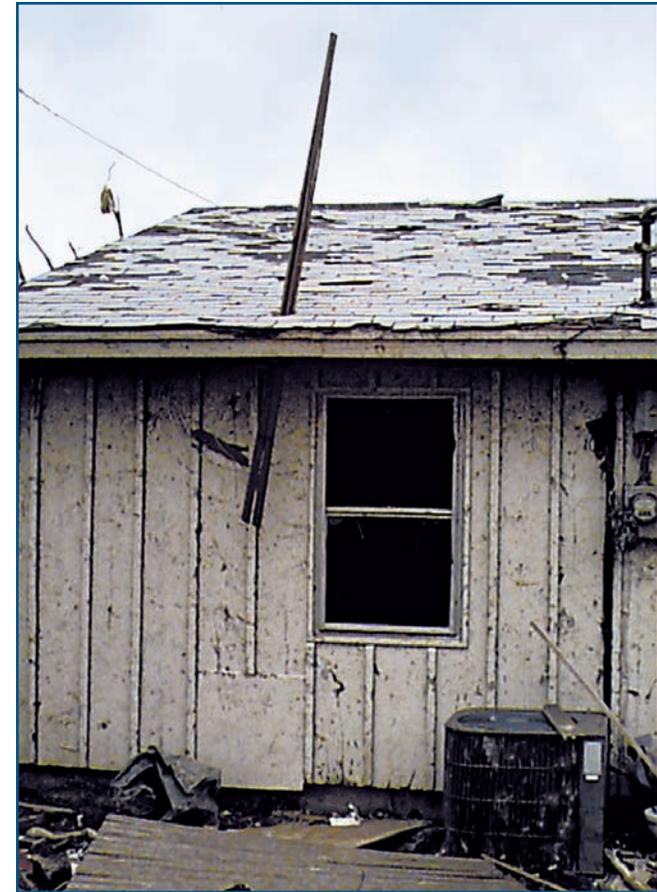
Figure 4-5
This photograph illustrates the importance of overhead protection in refuge areas. The missile shown here fell nearly straight down.

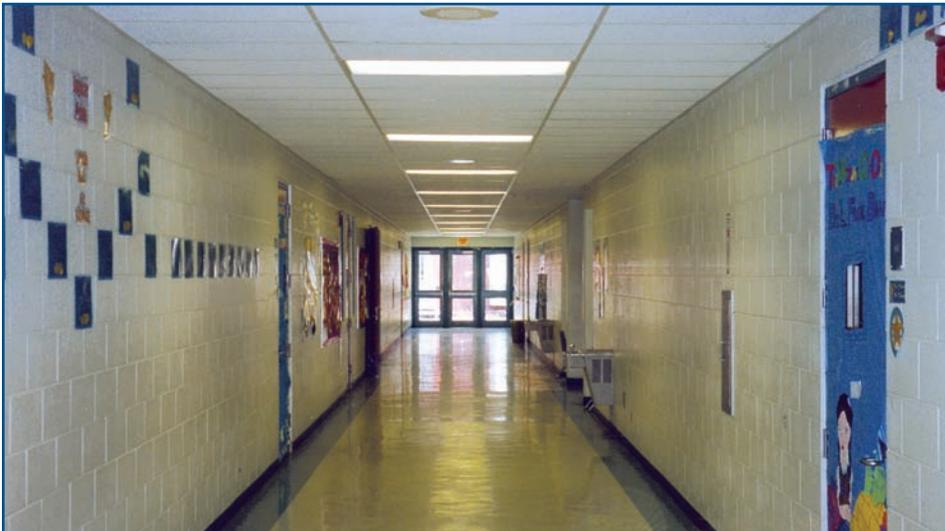
Figure 4-9
Interior central corridor – typical of the corridors in Buildings 200, 400, 600, and 800.

In each of the eight buildings, exterior and interior loadbearing concrete block masonry walls support the roof above. These walls are reinforced with vertical steel spaced at 2 feet 8 inches on center. Figure 4-10 shows a cross-section of one of the loadbearing corridor walls in Buildings 200,

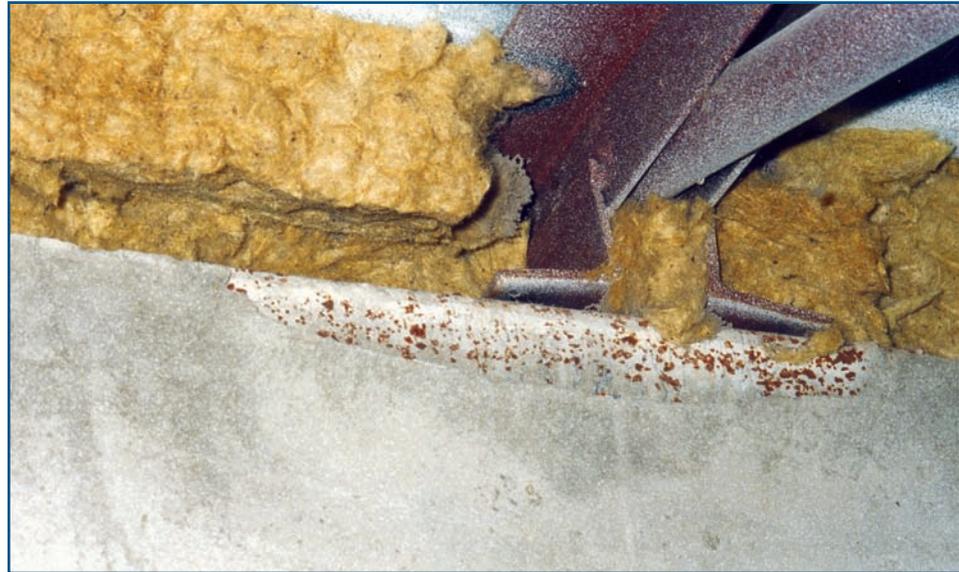
Figure 4-13 Typical roof truss connection to exterior wall in the example school.

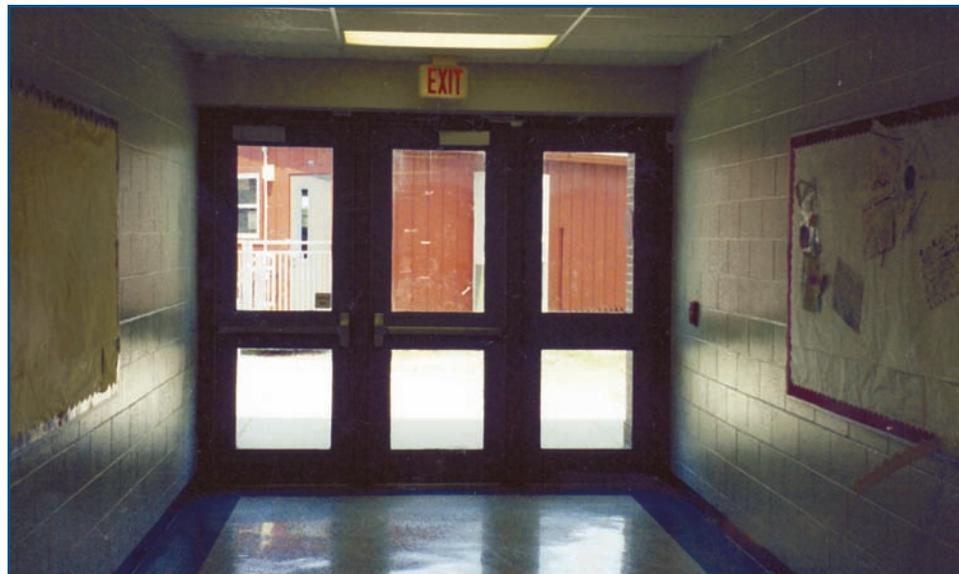
Figure 4-14 Exterior corridor doors in the example school.

The exterior windows in all eight buildings have aluminum frames and tempered glass. The exterior doors—including the exterior corridor doors in Buildings 200, 400, 600, and 800 (Figure 4-14)—are insulated metal-framed units with large windows. The doors from the corridors to the classrooms in these four buildings are wood with small windows (Figure 4-15).

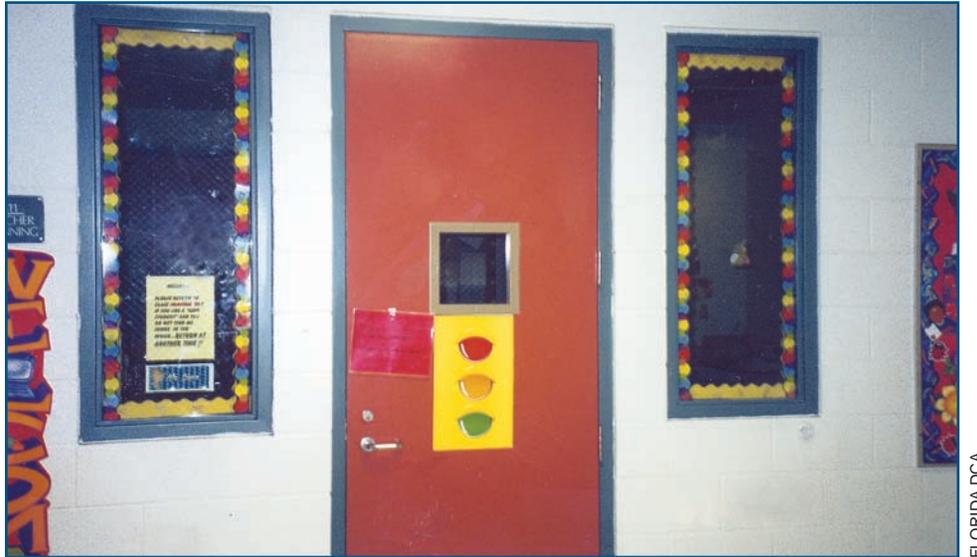
*Figure 4-15
Door connecting classroom to corridor – Buildings
200, 400, 600, and 800.*
